# Inspection Report

**Property Address:**  
89665 Main Ave.  
Las Vegas NV 89119

**Beacon Inspection Services**

<b>Date:</b> 7/5/2009	<b>Time:</b>	<b>Report ID:</b> 070509smit
<b>Property:</b> 89665 Main Ave. Las Vegas NV 89119	<b>Customer:</b> Mr. Jon Smith	<b>Real Estate Professional:</b>

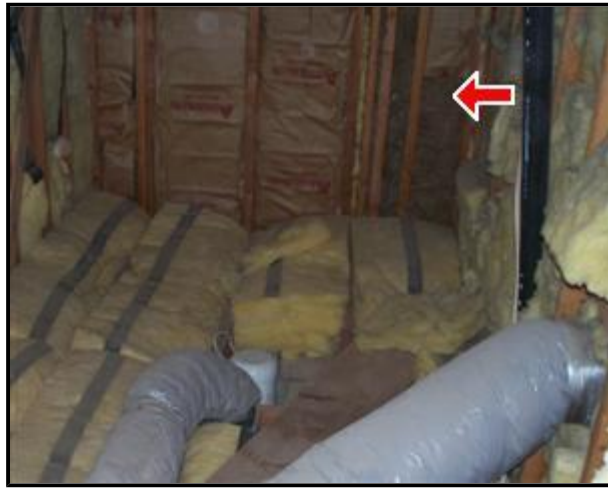
1.2 Picture 1

**1.2 (1)** The knee wall style of attic space(s) in this home requires that the attic to home common walls be very well insulated

and the attic space well ventilated to the outdoors. Some of the insulation batts have fallen off leaving the interior drywall exposed to the attic area.

**(2)** The knee wall style of attic spaces in this home require that the attic to home common walls be very well insulated and the attic space well ventilated to the outdoors. Some of the insulation batts have fallen down leaving the interior drywall exposed to the attic area.

I recommend adding at least 18 inches of batt fiberglass insulation to the homes walls in the attic.

I recommend adding at least 18 inches of batt fiberglass insulation to the homes attic walls.

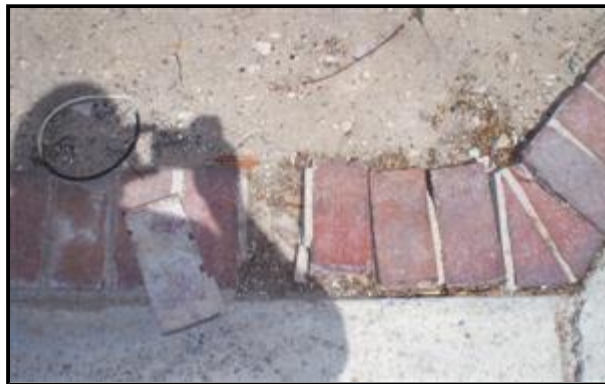
5.5 Picture 1

**5.5** Loose brick along sidewalk creates a trip hazard. Repair as needed as soon as possible.

Loose brick along sidewalk creates a trip hazard. Repair as needed as soon as possible.

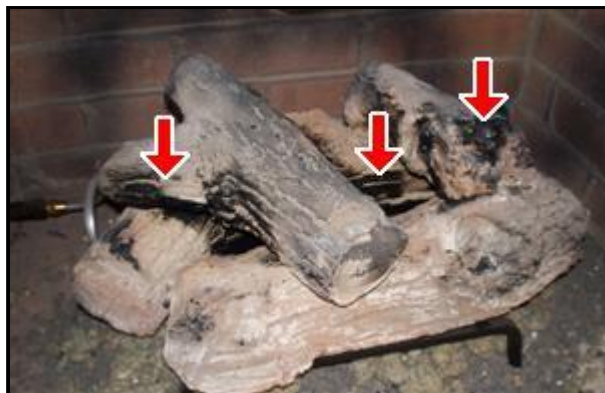
6.0 Picture 1

**6.0** As seen in the photo, the gas flames have been impinged to the extent that excessive sooting is occurring to the log set.

**WARNING! FOR YOUR SAFETY, DO NOT FIRE THE GAS SET UNTIL THE ENTIRE FIREPLACE, LOGSET AND CHIMENY HAVE BEEN SERVICED BY A PROPER FIREPLACE TECHNICIAN!**

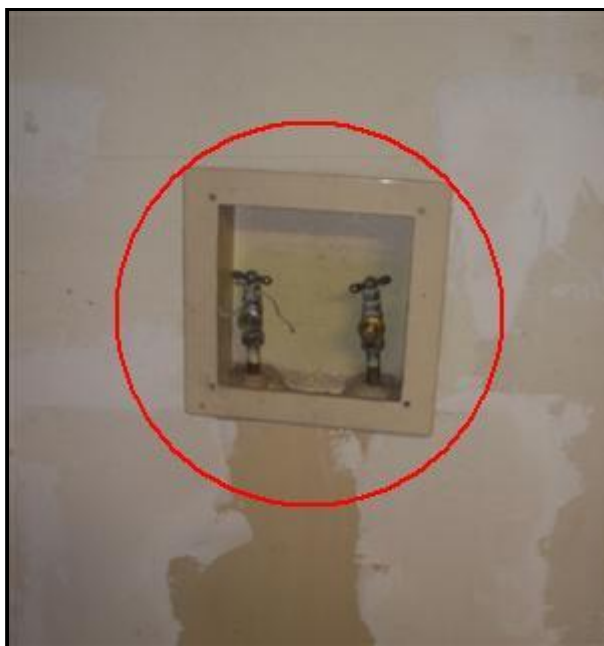
7.2 Picture 1

**7.2** The Garage walls/ceiling that are common to the home are clad in drywall that is designed to retard the advance of a fire should one start. The system has breaches to the wall cladding. such as those in the photo(s), that could allow fumes, smoke and fire into the home.

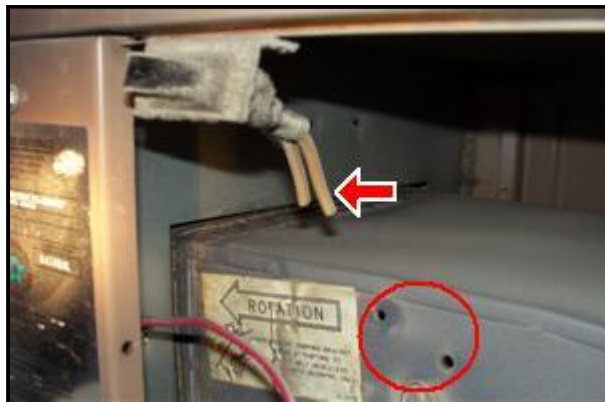
8.0 Picture 1

**8.0** As seen in the photo, the furnace cover safety switch has been disabled. Also note the holes in the plenum. Holes in furnace plenum need sealing for best efficiency.

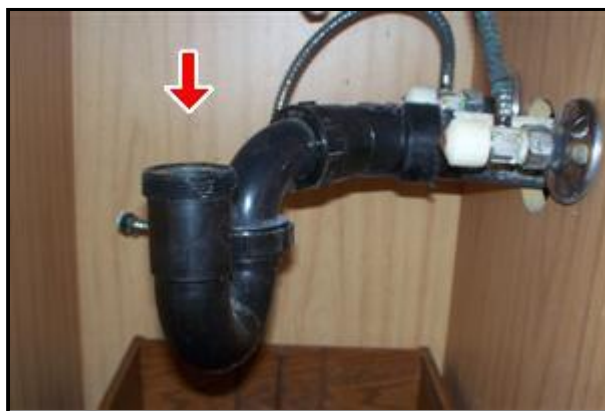
12.0 Picture 1

**12.0** A wet bar had been removed from the cabinetry in the Living Room but the drain and water supply piping were not. The present drain piping configuration can allow noxious sewer gases to leak back into the home that can cause personal injury.

A wet bar had been removed from the cabinetry in the Living Room but the drain and water supply piping were not. The present drain piping configuration can allow noxious sewer gases to leak back into the home that can cause personal injury.

**WARNING! FOR YOUR SAFETY, HAVE THE SITUATION CORRECTED IMMEDIATELY BY A LICENSED PLUMBER!**

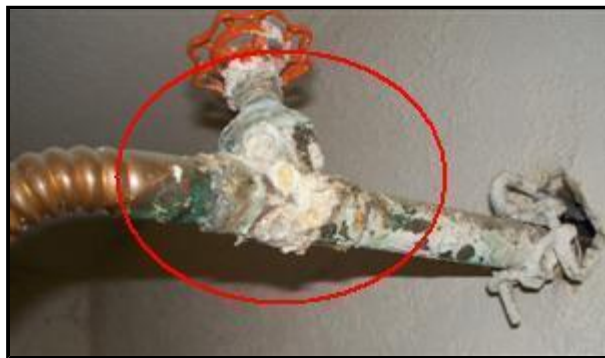
12.1 Picture 1

**12.1** Cold supply line has a corroded valve in the garage and needs replacing.

Cold supply line has a corroded valve in the garage and needs replacing.

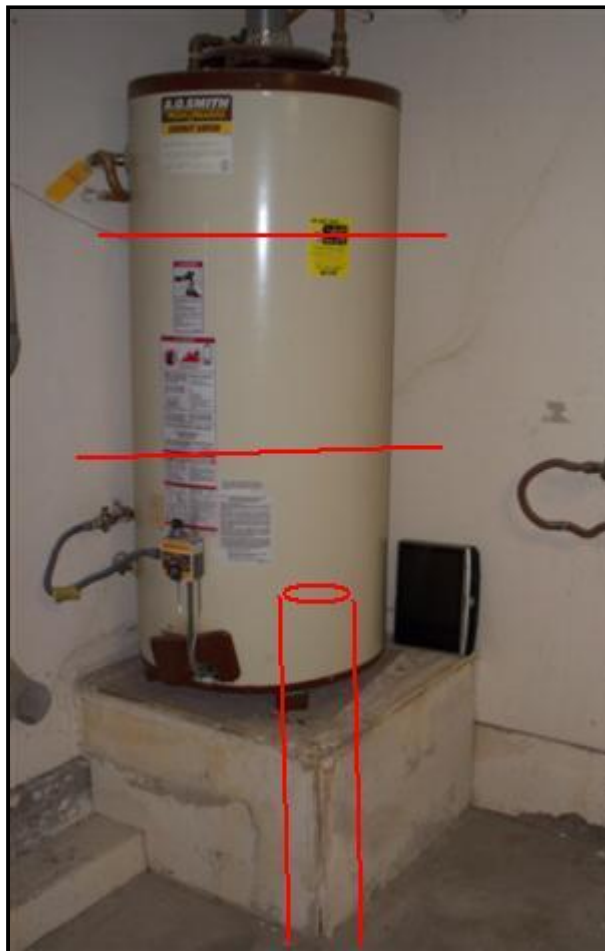
12.3 Picture 1

**12.3** Water heater is located in the garage and lacks seismic straps and a protective bollard. I recommend both as a safety upgrade.

Also, the support base is moisture damaged and deteriorating. Repair as needed for best support.

Water heater is located in the garage and lacks seismic straps and a protective bollard. I recommend both as a safety upgrade.

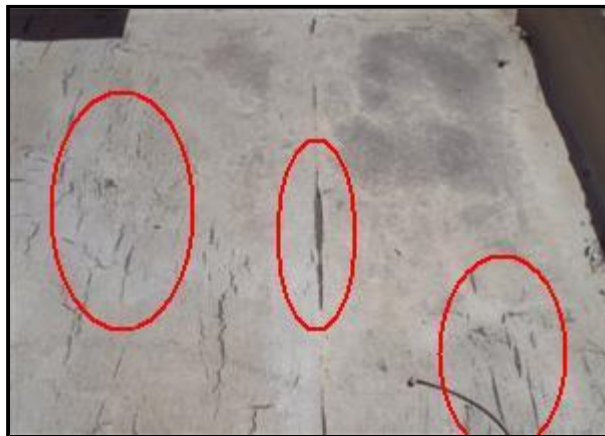
13.0 Picture 1

**13.0** Low slope roof areas have asphalt roll roofing installed. Asphalt roll roofing is not designed for this application and, as

seen in the photo, severe damage is occurring to it.

I recommend replacement of all flat roof coverings with the appropriate type material by a licensed roofing contractors soon as possible to avoid possible moisture intrusion into the house.

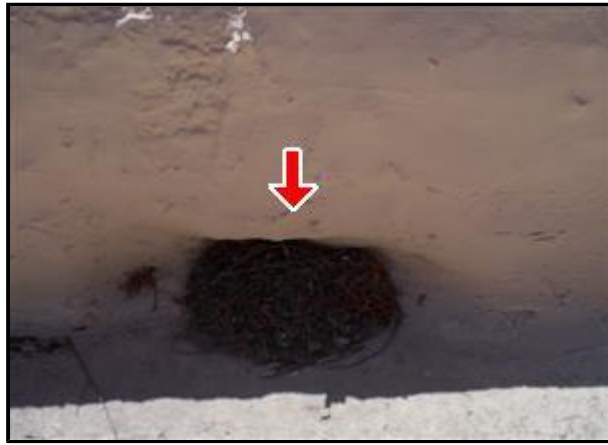
13.3 Picture 1

**13.3** Gutters need cleaning of debris around the entire building. Gutters that drain poorly or are clogged can lead to many costly problems such as deterioration of fascia, soffit or roof edge. It can also cause gutters to pull loose and lead to possible water intrusion. Keep gutters clean and free flowing for best moisture control.

costly problems such as deterioration of fascia, soffit or roof edge. It can also cause gutters to pull loose and lead to possible water intrusion. Keep gutters clean and free flowing for best moisture control.

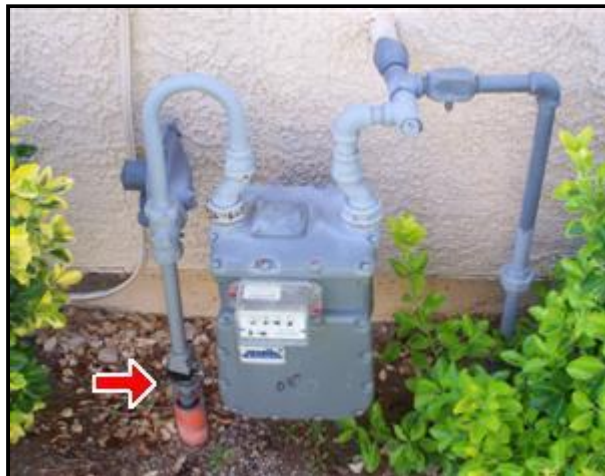
15.0 Picture 1

**15.0** The gas shut off valve that should shut off the gas to the entire home at once is located the outside north wall of the home.

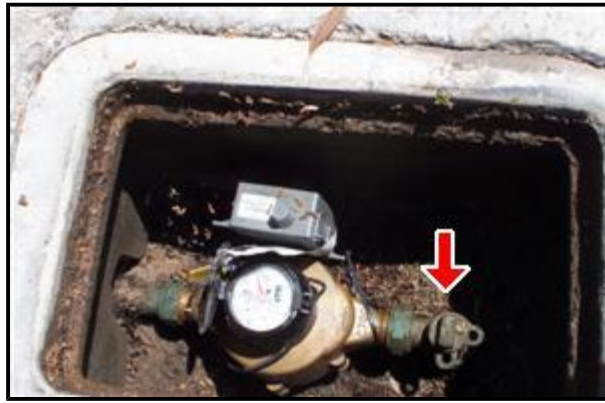
15.1 Picture 1

**15.1** The main water shut off that should turn off the water to the entire home at once is the valve located in the access box in the sidewalk at the street.

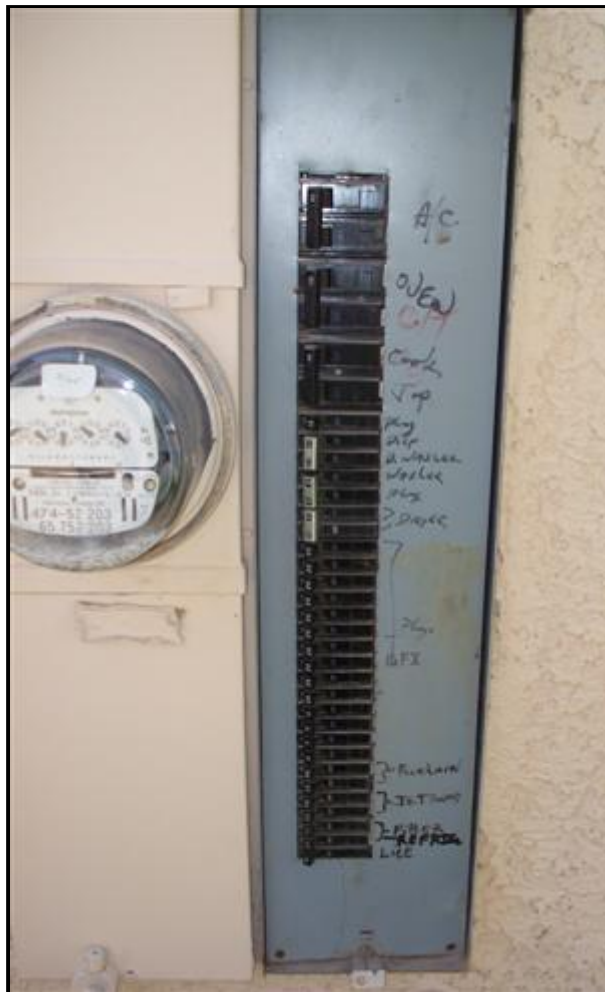
15.3 Picture 1

**15.3** The circuit breaker that should shut off all the electricity to the entire home at one time is located on the exterior of the garage in the electrical panel. Fast easy access to this panel is vital in case of emergency so keep a well cleared area in front of and around it in case emergency personnel, or you, need to access it quickly to shut off power to the home.
